**Flood Control Project Maintenance
Levee Inspections**

Maintenance Issue Types Only, Levee Inspection Report By Mile - Fall 2018

Tehama County Flood Control and Water Conservation District

Waterway	Bank	Unit Miles	Inspection Start/End	Inspector
Unit No. 01 Deer Creek	Left	4.22	10/02/2018 10/02/2018	Bob Duffey

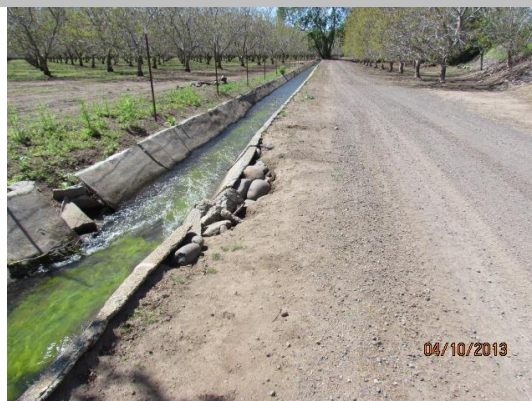
Photo 1 of 1 : FA_2018_NA0019_78_18_20180905_00006.jpg

View of the erosion along the landside slope.

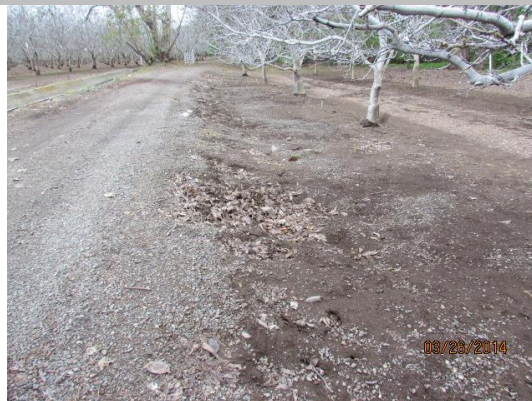
Photo 1 of 1 : FA_2018_NA0019_78_276_20180905_00019.jpg

LM Start	0.45	Rating **	M	Issue No.	276
LM End	0.45	Issue Type +	Ma	Location *	WS
Category	Earthen Levee			GPS Latitude/Longitude	
				Start	End
Item	Slope Stability			39.972377 °	39.972377 °
				-121.988559 °	-121.988559 °
DWR ID	DWR_NA0019_01_s_2014_276				
Comment Code					
S1 : Repair slope instability.					
Inspector Comment

View of the erosion along the waterside slope.

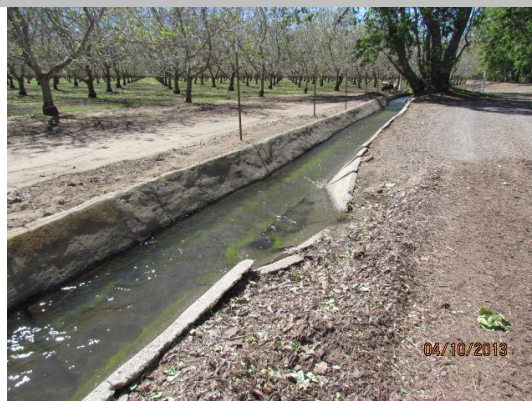
Photo 1 of 1 : FA_2018_NA0019_78_19_20180905_00007.jpg

View of the erosion along the landside slope.

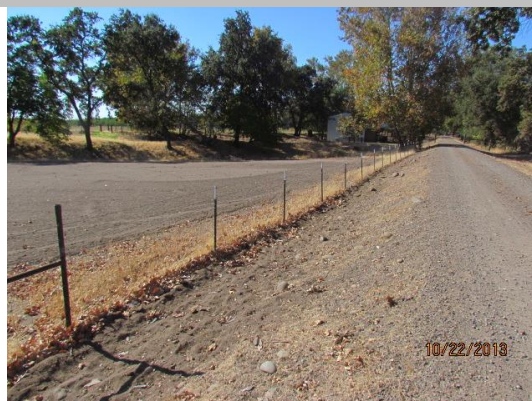
Photo 1 of 1 : FA_2018_NA0019_78_21_20180905_00009.jpg

LM Start	1.47	Rating **	M	Issue No.	21
LM End	1.47	Issue Type +	Ma	Location *	LS
Category	Earthen Levee			GPS Latitude/Longitude	
				Start	End
Item	Slope Stability			39.969702 °	39.969702 °
				-122.006975 °	-122.006975 °
DWR ID	DWR_NA0019_01_f_2013_21				
Comment Code					
S2 : Repair the levee slope damaged by foot traffic and prevent access where possible.					
Inspector Comment					
Keep livestock off levee and repair damage.

View of the erosion caused by livestock on both slope of the levee.

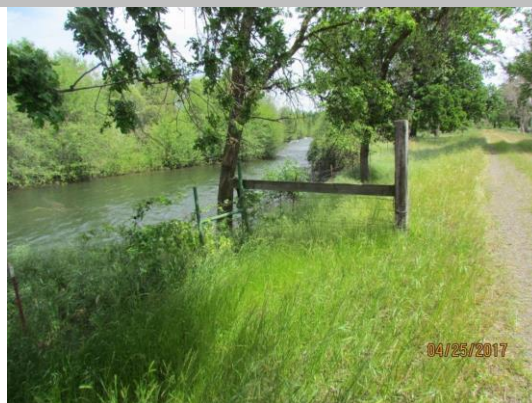
Photo 1 of 1 : FA_2018_NA0019_78_42_20180905_00016.jpg

LM Start	1.55	Rating **	A/W	Issue No.	42
LM End	1.58	Issue Type +	Ma	Location *	WS
Category	Earthen Levee			GPS Latitude/Longitude	
				Start	End
Item	Erosion / Bank Caving			39.969193 °	39.969052 °
				-122.008458 °	-122.008920 °
DWR ID	DWR_NA0019_01_s_2017_42				
Comment Code					
E2 : Schedule repair of erosion site prior to the next inspection.					
Inspector Comment					
Repair the erosion along the water side toe.

View of the erosion along the waterside toe.

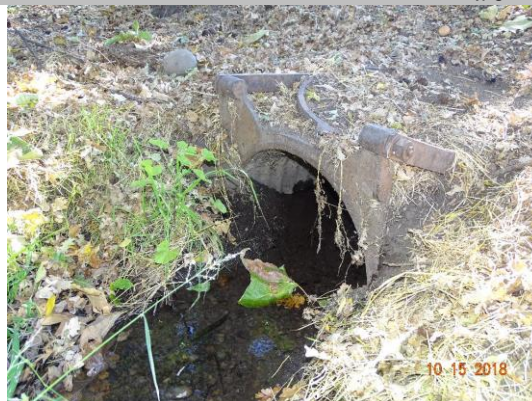
Photo 1 of 3 : UCIP_FA_2018_53391_78193.jpg

Item	DWR UCIP LMA Responsibility		39.968642 °	39.968642 °								
			-122.010494 °	-122.010494 °								
DWR ID	20770											
Comment Code												
Inspector Comment												
FS_ID: 53391 DS_ID: 20770 EP_NO: N/A Repair Type: Urgent Crossing Status: Found UCIP Comments: 10/15/2018 Flap gate on WS end stuck open. Lower part of pipe is silted that makes impossible flap gate to fully close. Needs sediment cleanup around pipe outlet on WS. (O. Yakimov - DWR) 12/05/2016 Sediment buildup inside pipe (see photo) and sediment buildup on WS blocking flap gate. Crossing has been downgraded from Urgent to Non-Urgent crossing was closed on both WS and LS. (O. Magana - DWR UCIP) 10/02/2013 Flapgate blocked by soil buildup. (W. Wylie - DWR UCIP) FIELD_STRUCT_DESC: 24-inch steel drainage pipe through the levee, 1.5 feet below the crown. Flap gate on the waterside (WS) toe. [Additional Reference(s): DWR Levee Log, 1992. USACE Sacramento O&M Manual Unit 509, March 1957, As-built drawings available 50-4-2394 (Station 185+40)]. FS Date: 10/15/2018 3:31:56 PM

Open flap gate on WS end. Pipe is partially silted.

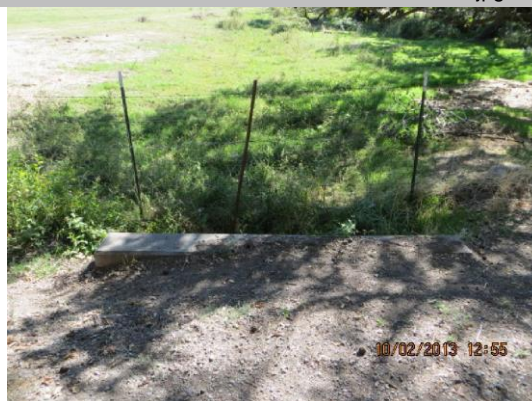
Photo 2 of 3 : UCIP_FA_2018_53391_36921.jpg

Comment Code						
Inspector Comment						
FS_ID:53391 DS_ID:20770 EP_NO: N/A Repair Type: Urgent Crossing Status: Found UCIP Comments: 10/15/2018 Flap gate on WS end stuck open. Lower part of pipe is silted that makes impossible flap gate to fully close. Needs sediment cleanup around pipe outlet on WS. (O.Yakimov - DWR)12/05/2016 Sediment buildup inside pipe (see photo) and sediment buildup on WS blocking flap gate. Crossing has been downgraded from Urgent to Non-Urgent crossing was closed on both WS and LS. (O. Magana - DWR UCIP)10/02/2013 Flapgate blocked by soil buildup. (W. Wylie - DWR UCIP) FIELD_STRUCT_DESC: 24-inch steel drainage pipe through the levee, 1.5 feet below the crown. Flap gate on the waterside (WS) toe. [Additional Reference(s): DWR Levee Log, 1992. USACE Sacramento O&M Manual Unit 509, March 1957, As-built drawings available 50-4-2394 (Station 185+40)]. FS Date: 10/15/2018 3:31:56 PM

Concrete headwall on LS toe.

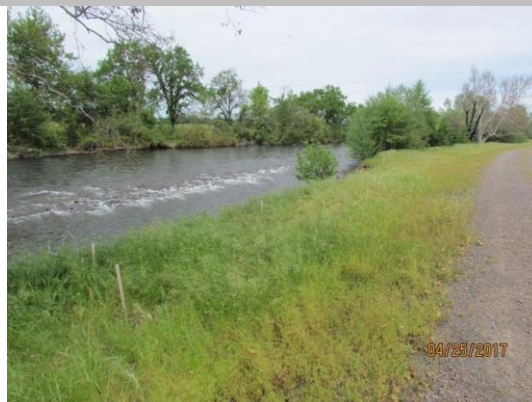
Photo 1 of 1 : FA_2018_NA0019_78_43_20180905_00017.jpg

LM Start	2.76	Rating **	A/W	Issue No.	43
LM End	2.78	Issue Type +	Ma	Location *	WS
Category	Earthen Levee		GPS Latitude/Longitude		
			Start	End	
Item	Erosion / Bank Caving		39.964990°	39.964763°	
			-122.028740°	-122.029082°	
DWR ID	DWR_NA0019_01_s_2017_43				
Comment Code					
E2 : Schedule repair of erosion site prior to the next inspection.					
Inspector Comment					
Repair the erosion along the water side slope.

View of erosion along waterside toe.

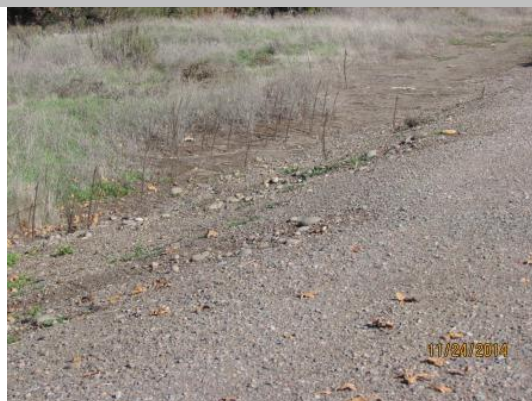
Photo 1 of 1 : FA_2018_NA0019_78_38_20180905_00013.jpg

LM Start	2.86	Rating **	M	Issue No.	38
LM End	2.86	Issue Type +	Ma	Location *	LS
Category	Earthen Levee			GPS Latitude/Longitude	
				Start	End
Item	Slope Stability			39.963928 °	39.963928 °
				-122.030120 °	-122.030120 °
DWR ID	DWR_NA0019_01_f_2014_38				
Comment Code					
S1 : Repair slope instability.					
Inspector Comment

View of erosion from the cattle on both slopes.

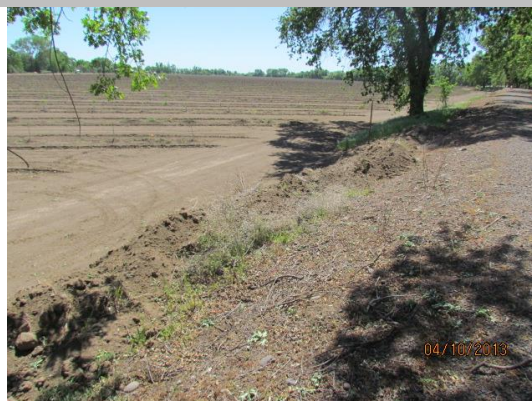
Photo 1 of 1 : FA_2018_NA0019_78_20_20180905_00008.jpg

LM Start	2.88	Rating **	M	Issue No.	20
LM End	2.88	Issue Type +	Ma	Location *	LS
Category	Earthen Levee			GPS Latitude/Longitude	
				Start	End
Item	Slope Stability			39.963709°	39.963709°
				-122.030384°	-122.030384°
DWR ID	DWR_NA0019_01_s_2013_20				
Comment Code					
S1 : Repair slope instability.					
Inspector Comment

View of the erosion along the landside slope.

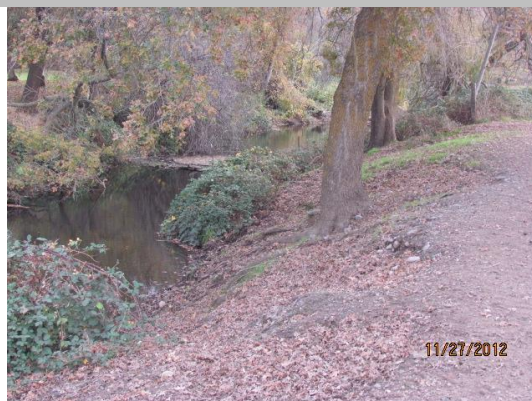
Photo 1 of 1 : FA_2018_NA0019_78_15_20180905_00003.jpg

LM Start	3.68	Rating **	M	Issue No.	15
LM End	3.68	Issue Type +	Ma	Location *	LS
Category	Earthen Levee			GPS Latitude/Longitude	
				Start	End
Item	Slope Stability			39.945045 °	39.945045 °
				-122.053469 °	-122.053469 °
DWR ID	DWR_NA0019_01_f_2012_15				
Comment Code					
S1 : Repair slope instability.					
Inspector Comment

View of the erosion caused by livestock along the landside slope.

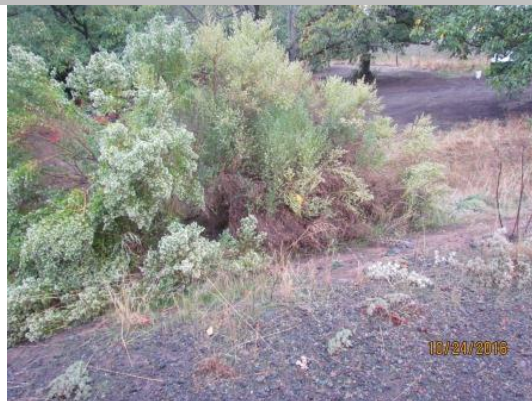
Photo 1 of 1 : FA_2018_NA0019_78_16_20180905_00004.jpg

LM Start	3.75	Rating **	M	Issue No.	16
LM End	3.75	Issue Type +	Ma	Location *	WS
Category	Earthen Levee			GPS Latitude/Longitude	
				Start	End
Item	Vegetation			39.944407 °	39.944407 °
				-122.054104 °	-122.054104 °
DWR ID	DWR_NA0019_01_f_2016_16				
Comment Code					
V2 : Remove the wild growth other than native grasses from the levee slopes.					
Inspector Comment

View of a bush obstructing visibility.

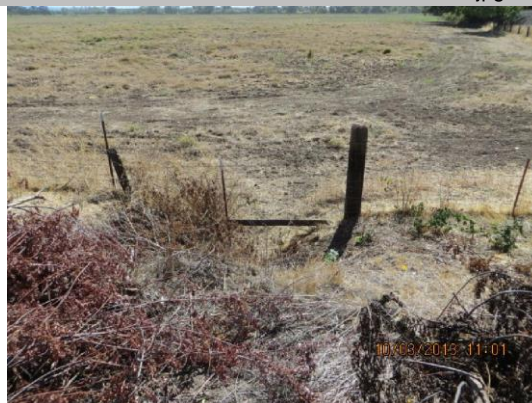
Photo 1 of 3 : UCIP_FA_2018_53395_36942.jpg

Comment Code						
Inspector Comment						
FS_ID:53395						
DS_ID:20762						
EP_NO: N/A						
Repair Type: Urgent						
Crossing Status: Found						
UCIP Comments: 10/15/2018 Missing flap gate at WS end of the pipe.						
Pipe is partially blocked with silt. Updated coordinates and CLM.						
(O.Yakimov - DWR)12/05/2016 unable to complete inspection --						
unable to locate. (O. Magana - DWR UCIP)10/03/2013 Gate missing						
from WS toe. (W. Wylie - DWR UCIP)						
FIELD_STRUCT_DESC: 24-inch corrugated metal drainage pipe						
through the levee, 5.5 feet below the crown. Flap gate located on the						
waterside (WS) end. Concrete headwall located on the landside (LS)						
toe. [Additional Reference(s): DWR Levee Log, 1992. USACE						
Sacramento O&M Manual Unit 509, March 1957, As-built drawing no.						
50-4-2394 (Station 0+65)].						
FS Date: 10/15/2018 3:37:24 PM

Inlet on LS toe.

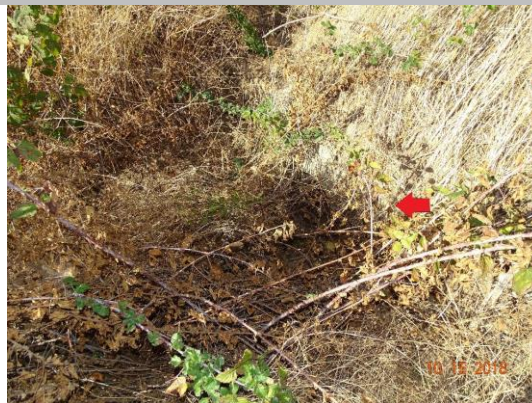
Photo 3 of 3 : UCIP_FA_2018_53395_78187.jpg

Comment Code						
Inspector Comment						
FS_ID:53395						
DS_ID:20762						
EP_NO: N/A						
Repair Type: Urgent						
Crossing Status: Found						
UCIP Comments: 10/15/2018 Missing flap gate at WS end of the pipe.						
Pipe is partially blocked with silt. Updated coordinates and CLM.						
(O.Yakimov - DWR)12/05/2016 unable to complete inspection --						
unable to locate. (O. Magana - DWR UCIP)10/03/2013 Gate missing						
from WS toe. (W. Wylie - DWR UCIP)						
FIELD_STRUCT_DESC: 24-inch corrugated metal drainage pipe						
through the levee, 5.5 feet below the crown. Flap gate located on the						
waterside (WS) end. Concrete headwall located on the landside (LS)						
toe. [Additional Reference(s): DWR Levee Log, 1992. USACE						
Sacramento O&M Manual Unit 509, March 1957, As-built drawing no.						
50-4-2394 (Station 0+65)].						
FS Date: 10/15/2018 3:37:24 PM

Concrete headwall at LS toe.

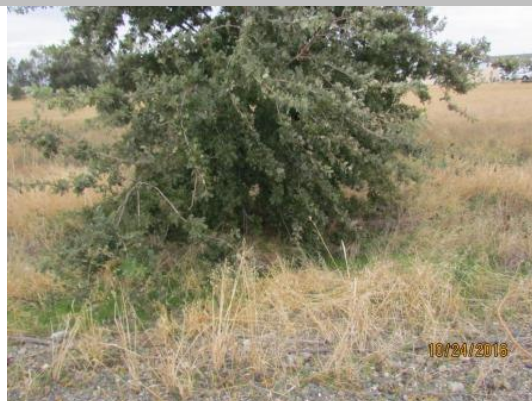
Photo 1 of 1 : FA_2018_NA0019_81_13_20180905_00008.jpg

View of a tree with overhanging branches.

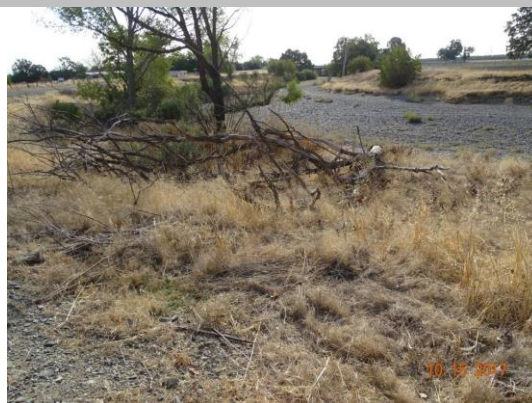
Photo 1 of 1 : FA_2018_NA0019_81_50_20180905_00022.jpg

View of the tree along waterside toe.

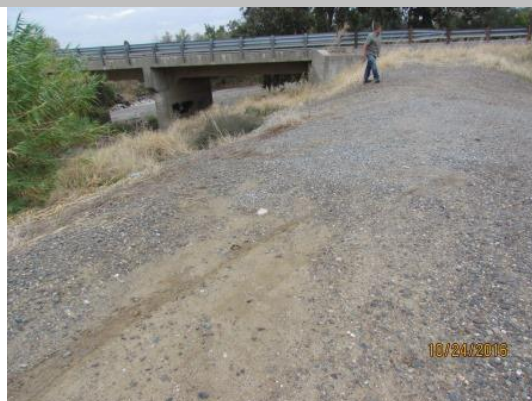
Photo 1 of 1 : FA_2018_NA0019_81_27_20180905_00015.jpg

View of the slope instability caused by vehicles.

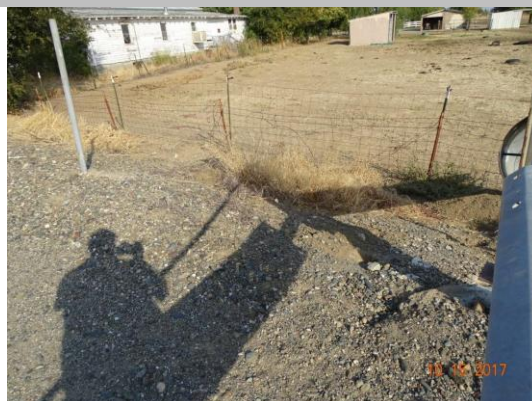
Photo 1 of 1 : FA_2018_NA0019_81_51_20180905_00023.jpg

View of the rodent holes along the landside slope.

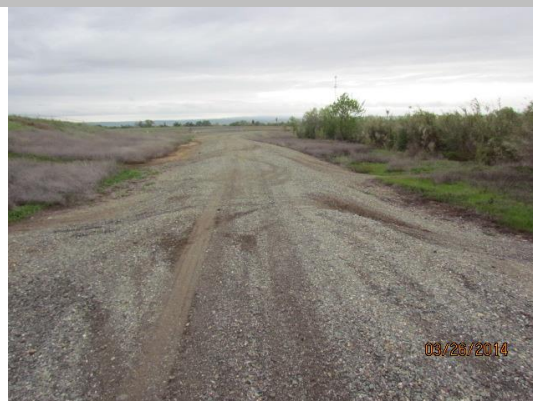
Photo 2 of 2 : FA_2018_NA0019_81_3_20180905_00004.jpg

View of the levee slope damaged by vehicle traffic.

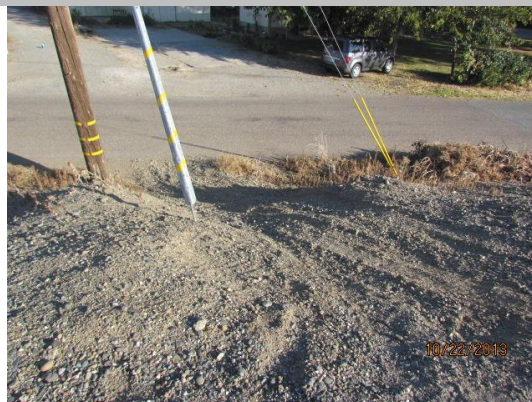
Photo 1 of 1 : FA_2018_NA0019_81_12_20180905_00007.jpg

View of the slope instability caused by vehicles along the landside slope.

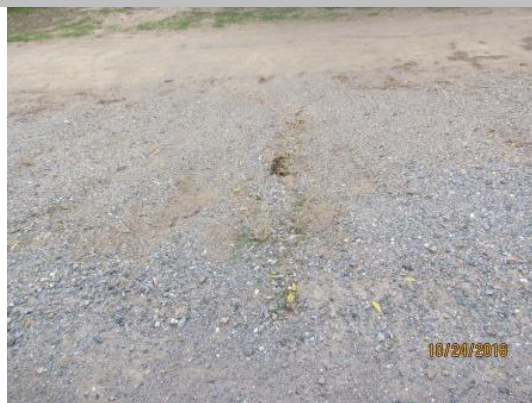
Photo 1 of 1 : FA_2018_NA0019_81_916_20180905_00024.jpg

View of the slope instability caused by vehicles along the waterside slope.

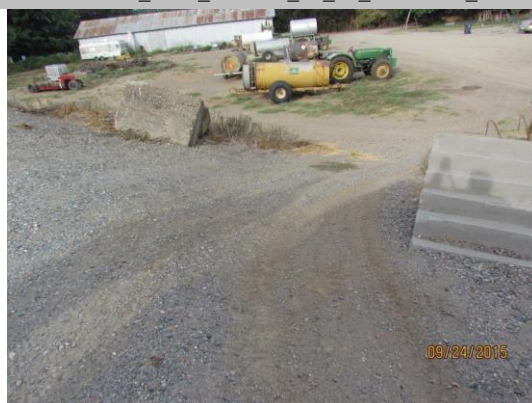
Photo 1 of 1 : FA_2018_NA0019_81_25_20180905_00014.jpg

View of the slope instability caused by vehicles along the landside slope.
